CRUXCAN

Dental PSP Scanner

Troubleshooting

Version: 1.0.0.5
Rev. Date: 2021.12.09

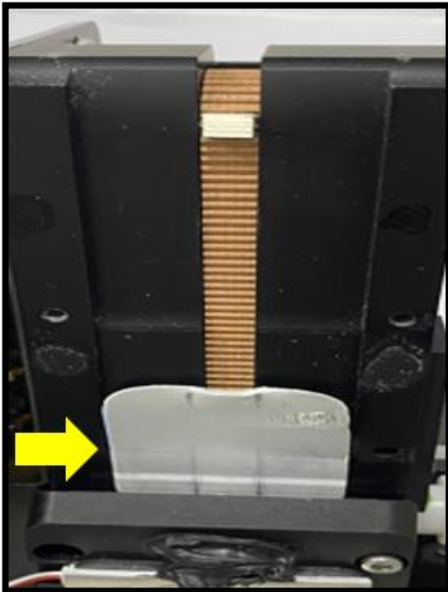
Cause	
<ul style="list-style-type: none"> While the scan was not finished due to the user's mistake, another IP insert. When the hygienic bag or protective Cover is inserted together. 	
Cause image	
<div style="display: flex; justify-content: space-around; align-items: flex-end;"> <div style="text-align: center;">

<p>IP Stuck</p> </div> <div style="text-align: center;">

<p>Attachment broken</p> </div> </div>	
Solution	
<ul style="list-style-type: none"> Refer to the IP remove guide and try to disassemble the scanner. (If the attachment is damaged, replace the belt). 	
Reference	
<ul style="list-style-type: none"> Refer [CRUXCAN] PSP(IP) remove guide video. Refer [CRUXCAN] Timing belt Replace guide video. (if you need the replace belt)' (If need the guide, please contact technical support).

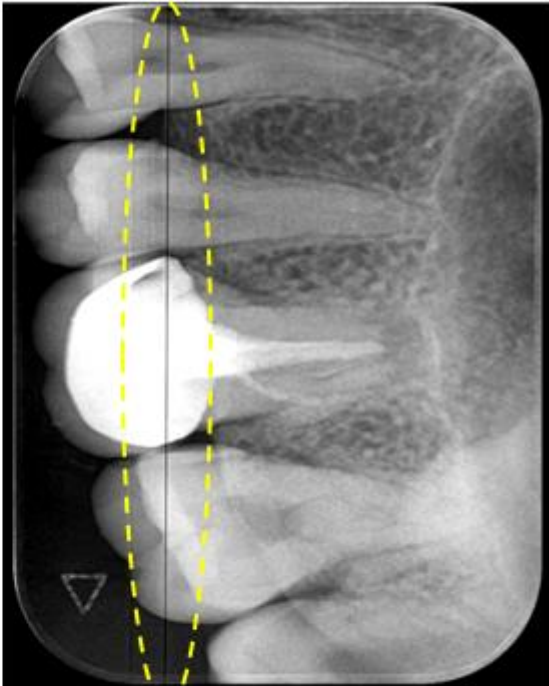
Symptom
<ul style="list-style-type: none"> If line appears continuously in the image after scanning.
Symptom image
<div style="display: flex; justify-content: space-around; align-items: flex-end;"> <div style="text-align: center;">

<p>Dust image</p> </div> </div>
Solution
<ul style="list-style-type: none"> Try to clean the optical filter.
Reference
<ul style="list-style-type: none"> Refer [CRUXCAN] Filter cleaning guide(+reflector).

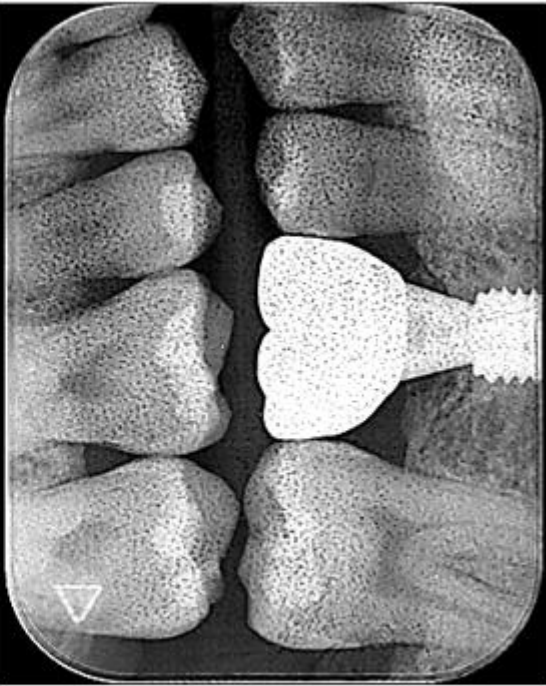
Symptom
<ul style="list-style-type: none"> If stains, fingerprints, or dots appear on the image after scanning.
Symptom image
<div style="display: flex; justify-content: space-around; align-items: center;"> <div style="text-align: center;">

<p>Chemical image</p> </div> </div>
Solution
<ul style="list-style-type: none"> Try to clean IP. If the scanned image shows the same problem after IP cleaning, replace the IP as it is damage.
Reference
<ul style="list-style-type: none"> Refer [CRUXCAN] PSP(IP) cleaning guide.

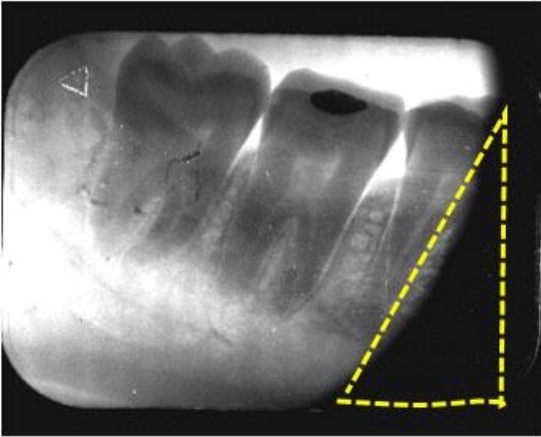
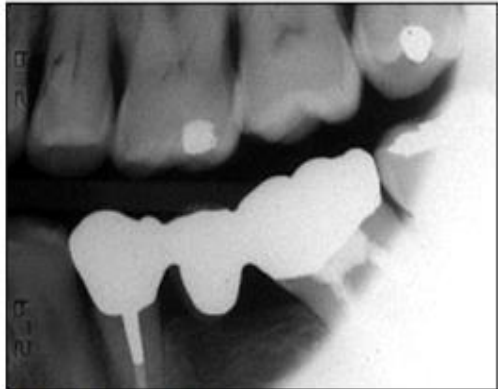
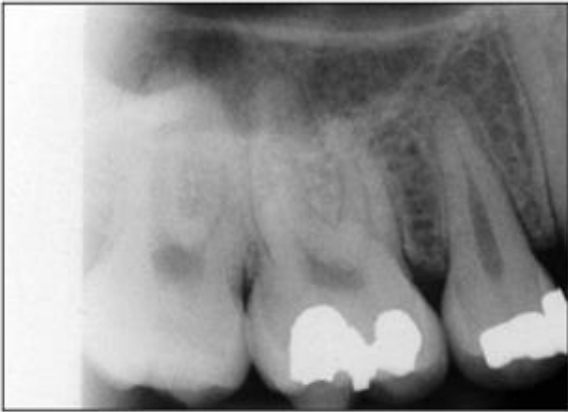
Symptom	
<ul style="list-style-type: none">If the image appears different after scanning.	
Symptom image

PC image	Cone cut image

Round Cone Cut	Rectangular Cone Cut
Solution	
<ul style="list-style-type: none">When using x-ray, be carefully not to cause a cone cut.

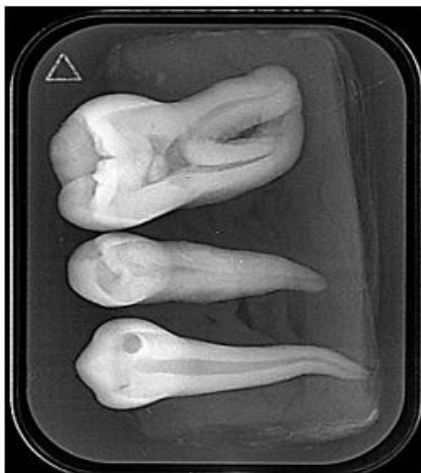
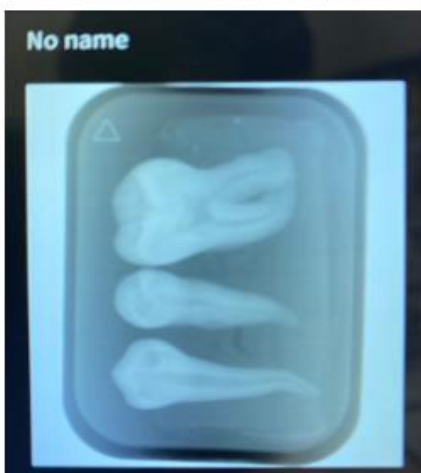
- If the border(band) appear in the scanned image.

Border(band) image

Border(band) image
(Scanner LCD)

- Attempt to take an x-ray in the correct direction of the IP (blue side).
(Wrong direction : If the IP is x-rayed orange side)

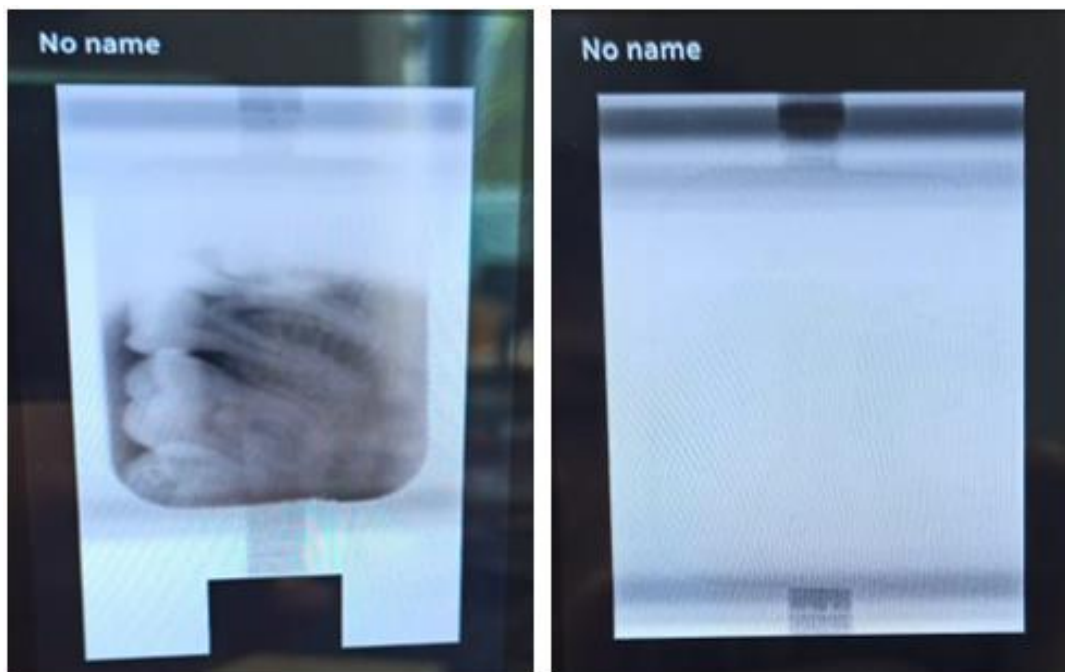
- If the white background or black band appears in scanner LCD after scanning.

- Check that the light-blocking accessories are on the top cover.
(If the light-blocking accessories do not close, contact Technical Support)

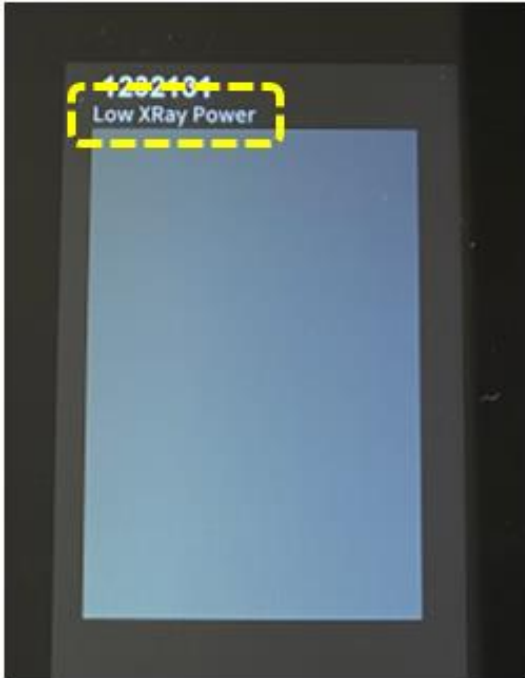
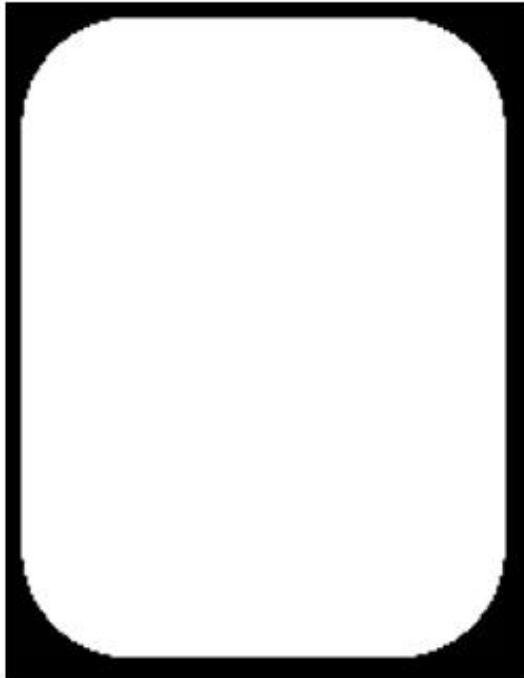
Symptom	
<ul style="list-style-type: none">If the white image appears after scanning. (‘Low Xray power’ message appears on the scanner LCD)	
Symptom image

Scanner LCD	PC image
Solution	
<ul style="list-style-type: none">After increasing the dose of the x-ray, try to scan. (Appears when the exposed x-ray power is very low or If it wasn't shot correctly)

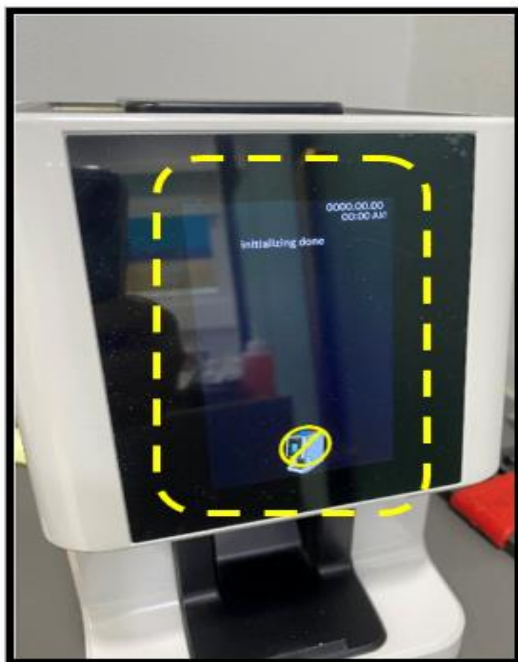
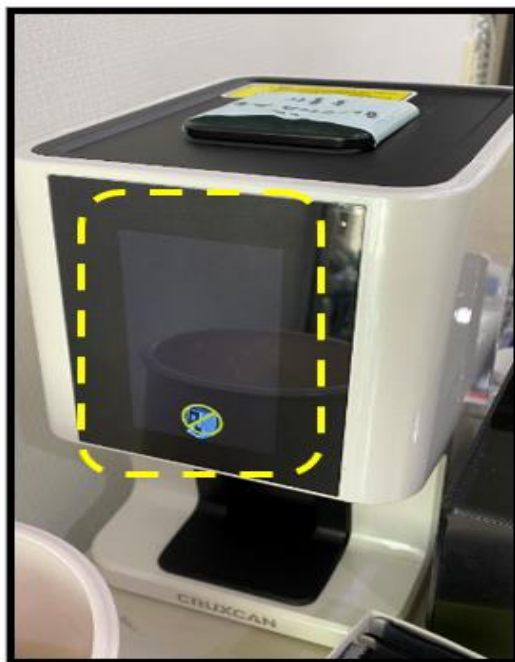
- LCD screen is not initialized or responded.

- Check the LCD cable connection is well or not and try to reconnect it.

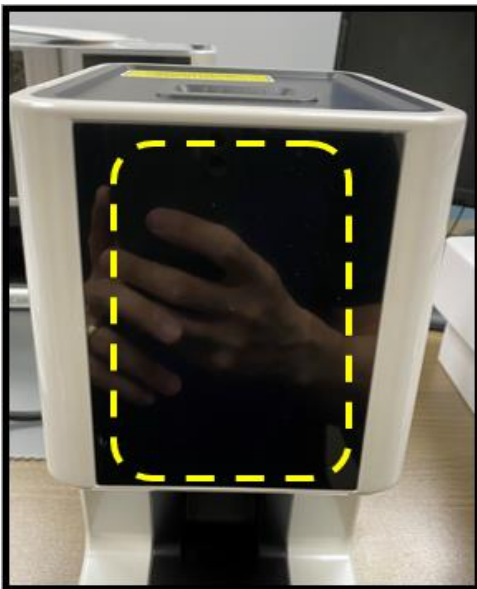
Symptom
<ul style="list-style-type: none">LCD screen automatically turns off.Scanner power turns off.
Symptom image

Solution
<ul style="list-style-type: none">Touch the sleep mode icon to turn it off.Check the power connection port LED light status.Check the power adapter light.(normal color: blue)
