CRUXCAN

Dental PSP Scanner

Troubleshooting

Version: 1.0.0.5
Rev. Date: 2021.12.09

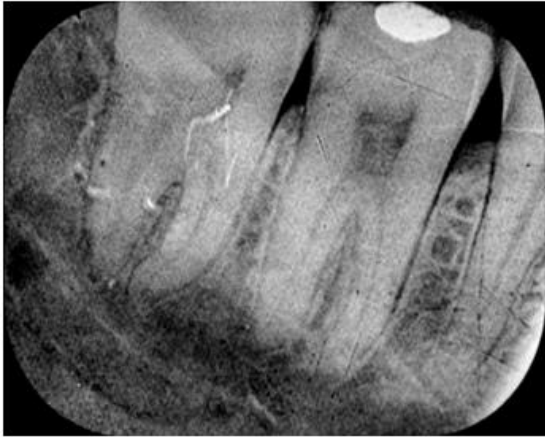
Symptom	
<ul style="list-style-type: none">If the image appears different after scanning.	
Symptom image

Round Cone Cut	Rectangular Cone Cut
Solution	
<ul style="list-style-type: none">When using x-ray, be carefully not to cause a cone cut.

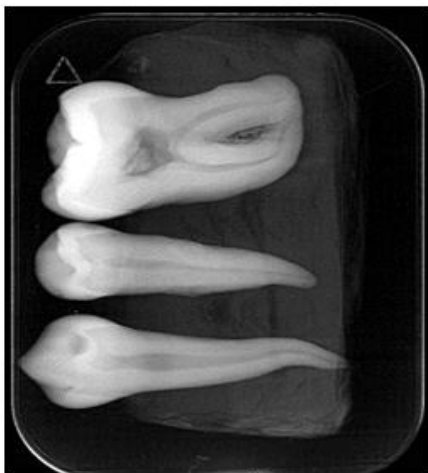
Normal image

- If the border(band) appear in the scanned image.

- Attempt to take an x-ray in the correct direction of the IP (blue side).
(Wrong direction : If the IP is x-rayed orange side)

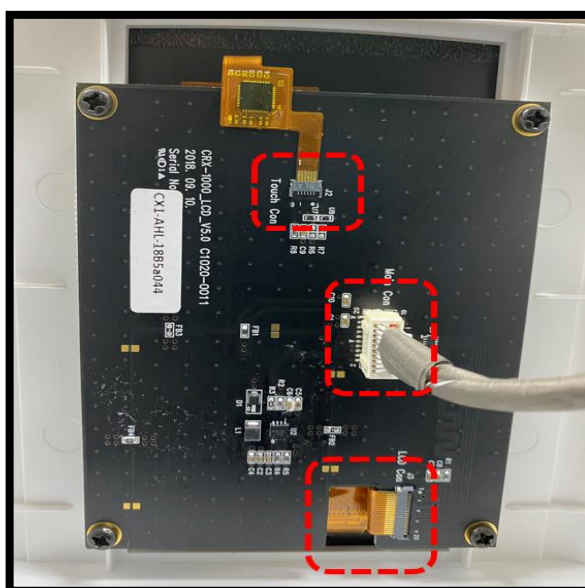
- LCD screen is not initialized or responded.

- Check the LCD cable connection is well or not and try to reconnect it.

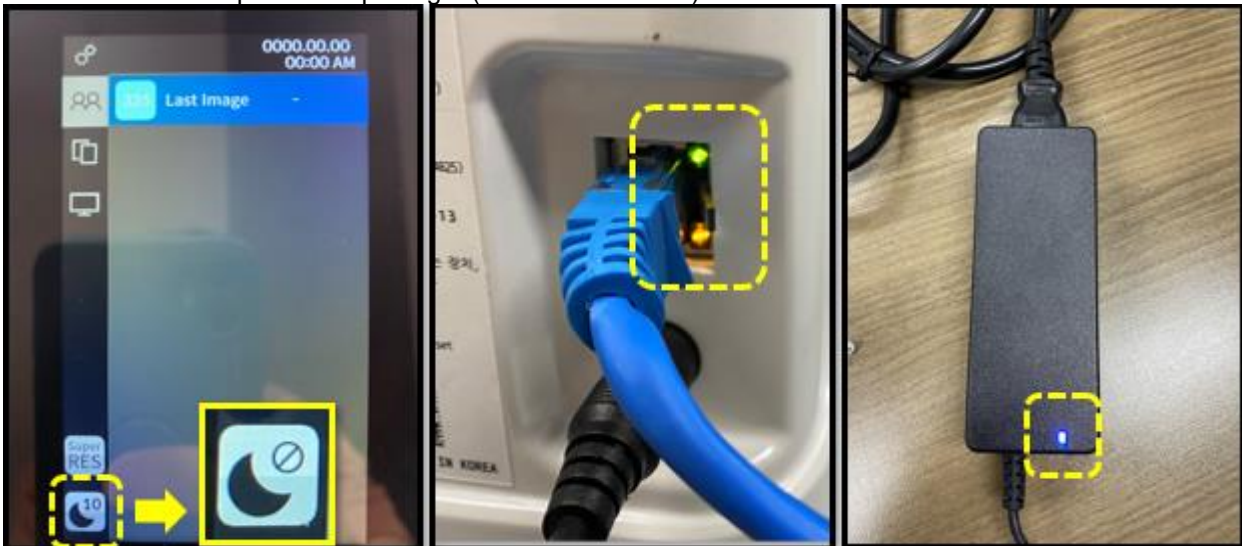
Symptom
<ul style="list-style-type: none">LCD screen automatically turns off.Scanner power turns off.
Symptom image

Solution
<ul style="list-style-type: none">Touch the sleep mode icon to turn it off.Check the power connection port LED light status.Check the power adapter light.(normal color: blue)
